**HVE-WP-2017-2**

## **Simulation of a Four-Car Collision Using SIMON/DyMESH**

**James R. Loumiet**

## WP 2017-2

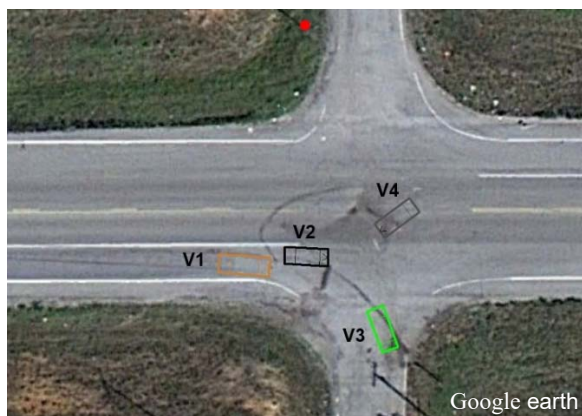
**Figure 1-Vehicle FR Positions & Tire marks**

Site data was collected from post-accident photographs, laser scans of the site, and from *Google Earth Pro* images. One of the *Google Earth Pro* images of the site was taken about 20 days after the accident so that tire marks from the accident were visible in the image. Vehicle final rest positions were determined from both post-accident measurements made by investigating police officers, and from the post-accident photographs using photogrammetry (see Figure 1).

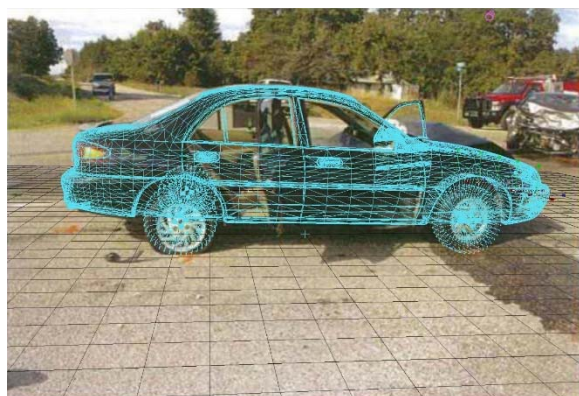
**Figure 2-Ford Escort Photogrammetry**

None of the vehicles were available for inspection for this study. Consequently, all vehicle crush dimensions were determined from post-accident photographs using photogrammetry (see Figures 2, 3, and 4).

A review of the post-accident photographs of the Ford Escort and Honda Civic showed that the front of the Escort underrode the rear end of the Civic during the first impact. Given the 3D nature of this impact and the damage, it was decided to use SIMON/DyMESH to simulate the collision to ensure that all vehicle motion and crush damage were simulated as accurately as possible.

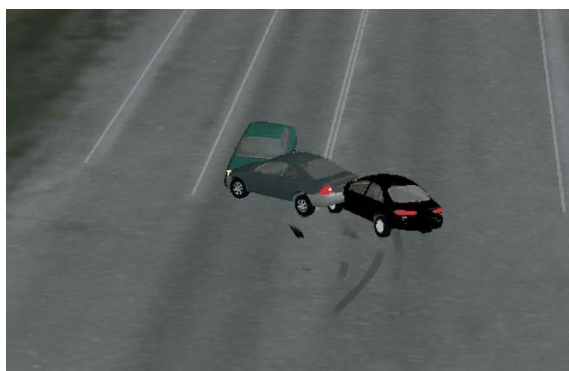
**Figure 5-Overlapping Impacts**

The first and second impacts had to be simulated within the same HVE event because these two impacts initiated only 0.62-second apart with the Escort and Civic still engaged when the second impact between the Civic and the Mazda Protégé occurred (See Figure 5). This point underscores the value of HVE in simulating a collision of this complexity as more traditional reconstruction methods (i.e. “pencil and paper” calculations) would not have been able to reliably handle the overlapping impacts.

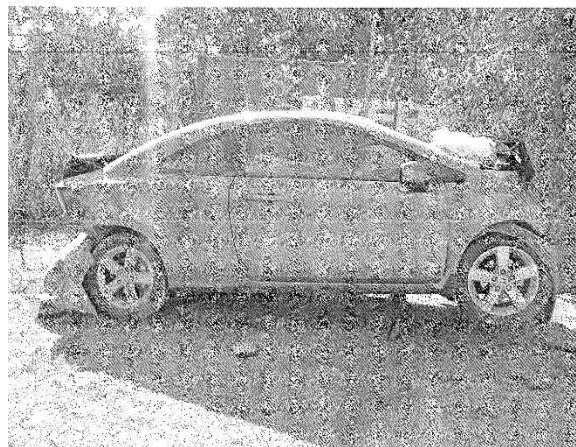
**Figure 6-Honda Civic Crush (Actual)**

Regarding the analysis of the specific impacts, the first impact involving the Escort and Civic was focused on first. The benefit of using this approach was that the Escort impact speed could be solved independent, for the most part, of the other two impacts. Only a relatively narrow range of Escort impact speeds produced an underride damage pattern consistent with the actual damage to the Escort and Civic (see Figures 6 and 7) and produced the post-impact movements, positions, and tire marks consistent with the site evidence.

An Escort impact speed of 45 mph provided the best fit solution for the first impact. Escort speeds much above 45 mph resulted in a rollover of the Civic, something that did not happen. However, the fact that SIMON/DyMESH can and did predict a

rollover at higher speeds in this case was helpful as it established an upper threshold for the Escort impact speed. Escort speeds much below 45 mph resulted in post-impact damage patterns and motion paths that were not consistent with the evidence.

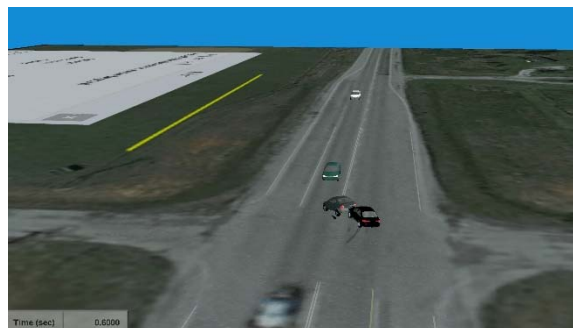
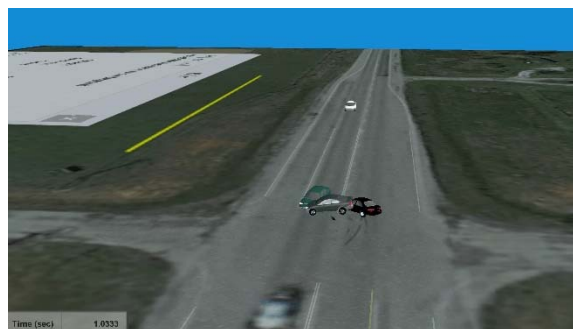
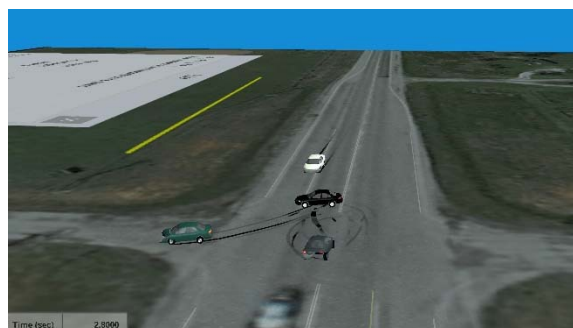
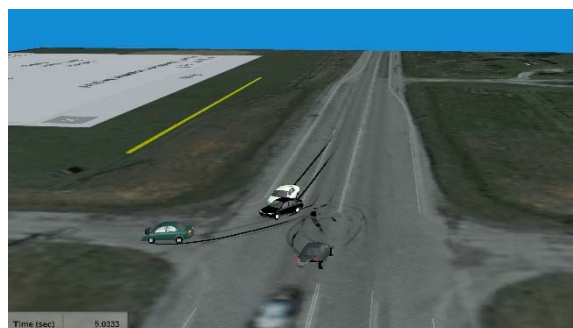
As a result of the first two collisions, the Civic yawed about 360 degrees to its final rest position. After the first collision, the Escort continued west and yawed counter-clockwise into the eastbound lanes where it was struck on its front passenger door by the Dodge Intrepid at an impact speed of about 20 mph. Figure 8a-d shows the collision sequence for all three impacts. Figures 9 and 10 show a comparison of the actual tire marks and those generated by HVE.
